Report

Serious incident on **15 April 2010**
south-east of Brive-la-Roche (19)
to the **Hawker Beechcraft Corporation Beech B200GT**
registered **F-HSFA**
operated by **SEFA**

BEA

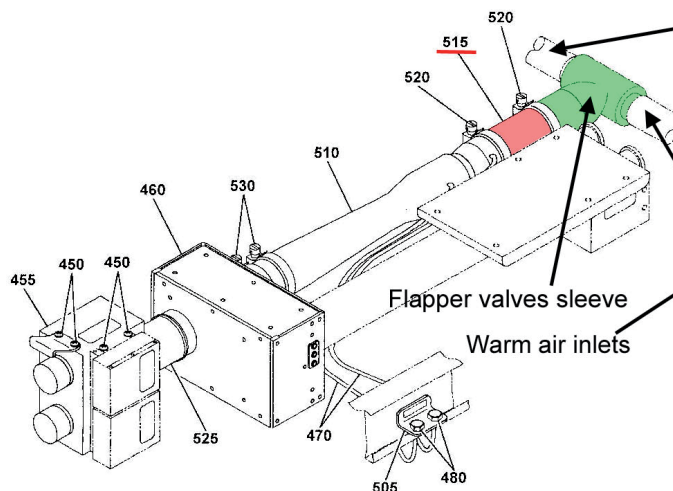
Figure 2: Drawing of the warm air distribution system

The maintenance operations carried out after the incident showed that the flexible sheath (ref. 515 in figure 2) was split and surrounded by a grey adhesive overlaid on a sheet of aluminium. They both bore traces of over-heating and were ripped:

- This sheath was damaged with a sharp instrument during a maintenance operation to check the smooth working of the flapper valves of the warm air power supply case.

The maintenance manual drawn up by HBC does not mention a solution for repairing these ducts. In the event of damage, they must be replaced.
